RAILWAY INVESTIGATION REPORT
R99H0009

COLLISION AT CROSSING

VIA RAIL CANADA INC.

MILE 290.50, RUEL SUBDIVISION

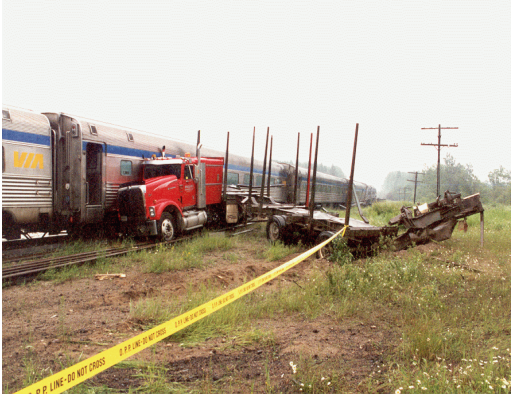
As the road and crossing were rough, the driver maintained a low rate of speed (approximately 15 km/h). There was a stop sign to the right of the road approximately 3 m before the crossing. The driver was aware of the sign and the requirement to stop. The driver elected not to stop at the stop sign as he believed that his truck could stop if he saw a train approaching and, through habit, never stopped at that crossing. The driver indicated that, at this time, he looked in both directions and did not see or hear a train. The driver stated that, once on the crossing, he again looked in both directions and did not see or hear a train. A few seconds later, as VIA 2 hit the trailer 15.85 m from the front of the truck and 14.02 m from the driver's location, the truck was thrown in an easterly direction and spun around, colliding with the first passenger car behind the three locomotives. The truck came to rest against the seventh passenger car (see Figures 1 and 2).

Figure 1—View of final position of truck and damage to trailer

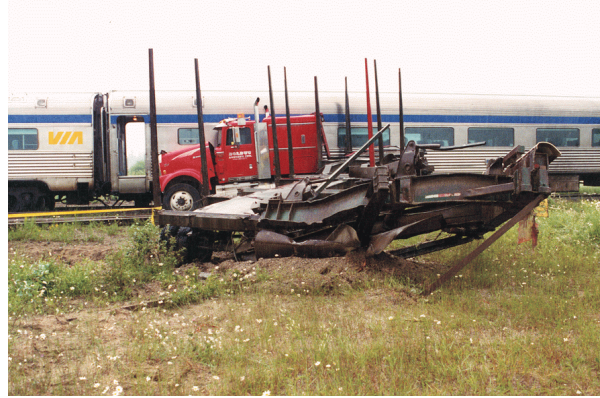
Figure 2—Damage to trailer

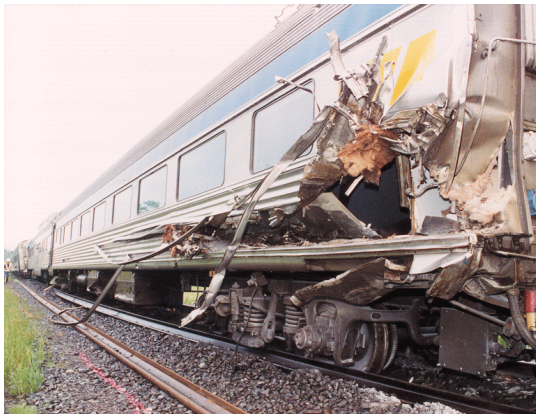
The first car behind the locomotives (8118) sustained significant damage to the south leading-end corner (see Figures 3 and 4). The damage extended to the inside of the car, tearing three sets of seats from their anchors in the floor, damaging the floor and baseboard heater and the overhead luggage rack, and destroying the end-of-car luggage rack and storage locker. The power junction box and cables were also damaged.

Figure 3—Outside damage from corner of tractor-trailer after rotation

behind the driver, struck the south leading corner of the first passenger car (see Figures 3 and 4). Because that car was empty, the potential for serious injuries was avoided but the car sustained significant damage to seats and also had debris thrown through it. This type of damage was evident in other accidents involving heavy trucks (TSB occurrence No. R92D0016 and occurrence No. R99S0100). Given the amount of damage suffered by the first car behind the locomotives and the conclusions of Engineering Laboratory study LP 110/2000, it is evident that passenger cars are not sufficiently protected against lateral damage, such that serious injuries to passengers are likely when the cars are struck by a heavy vehicle.

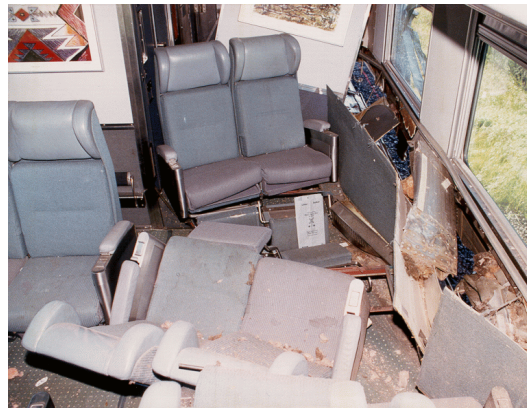
Figure 4—Inside damage from same impact

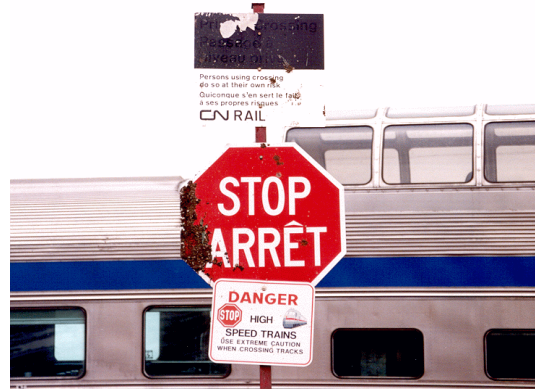
The Becker crossing was a private crossing at grade on a gravel road located at Mile 290.5 and was owned by Donahue. The Becker crossing was equipped with “maximum 30 km/h” signs, stop signs, and additional warning signs indicating “Danger High Speed Trains” on both approaches (see Figure 6). The road was straight and flat.

Figure 6—Signs displayed at the Becker crossing

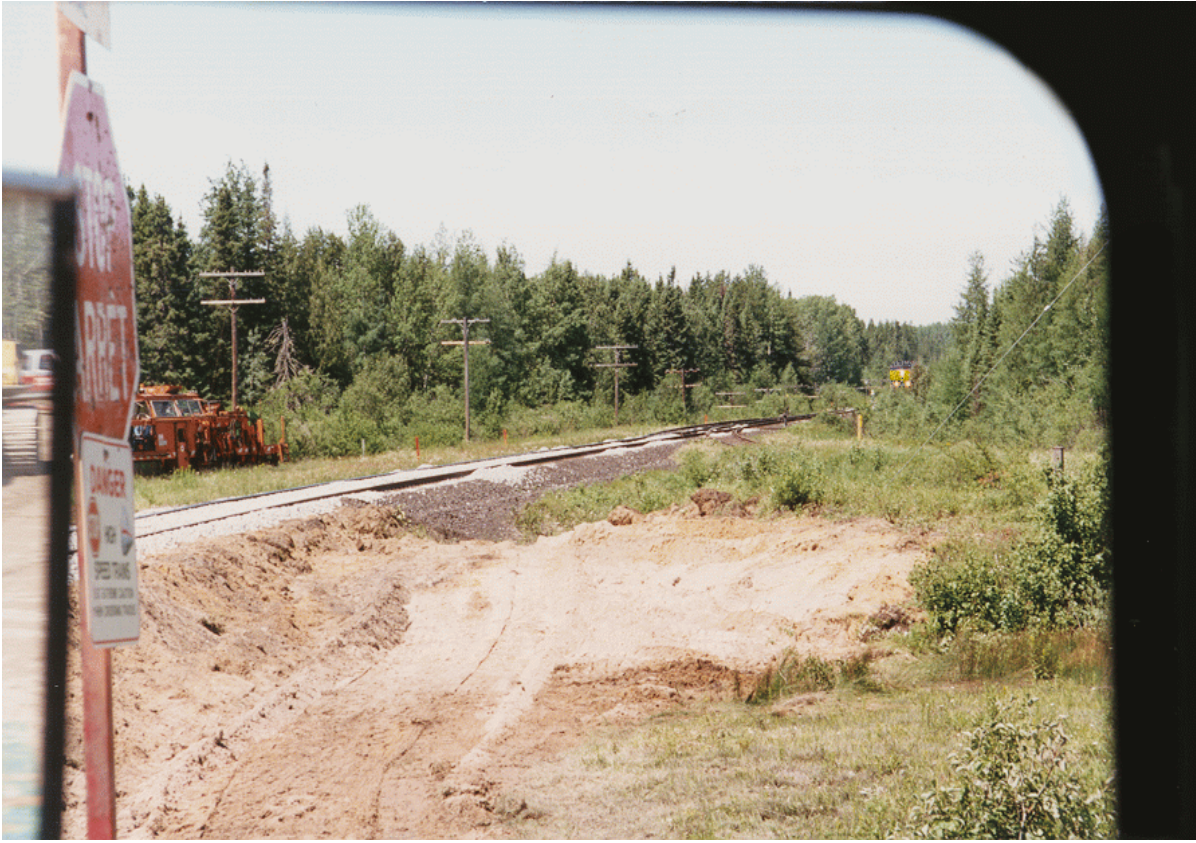
Figure 7—TSB simulation of actual view of approaching train from stop sign location

crossed, that distance should have been extended by 50 per cent, making the required sight-line 413 m. As previously stated, the actual sight-line in the direction of the train was 365 m, or 88 per cent of what it should have been according to guideline G4-A. Neither the railway nor TC had identified this discrepancy.

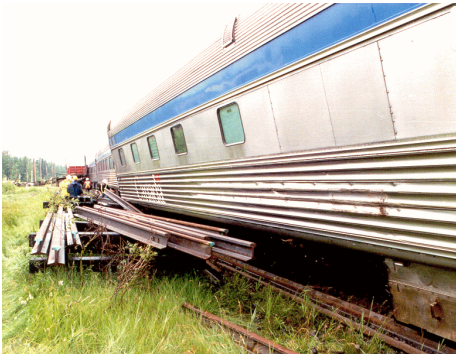
Figure 8—View of track material stored along the main track

Track material, consisting of ties stacked approximately 1.2 m high, pieces of rail of various length either resting on the ground or placed on top of the ties and piles of rail anchors and tie plates, was stored adjacent to the main track immediately east of the Becker crossing and on the south side of the main track. The track material had been placed at that location several months before the accident. Because of its proximity to the main track, this material was struck by the derauling train and the truck as it was being pushed along the track.

There are no rules relating to the placement of track material along the main track. This has been a safety issue raised in other TSB investigation reports (R94T0357, R95S0130) with respect to work material being left along the rights-of-way after work had been completed. However, the focus at that time was the risk of vandals causing an accident by placing material on the track rather than the risk of material near a track contributing to accident severity.
